ENGINEERING, FEASIBILITY AND ECONOMIC ANALYSIS STUDY OF METRO-NORTH RAILROAD BRIDGE OVER THE HOUSATONIC RIVER (DEVON BRIDGE)

Bridge No. 08080R, M.P. 60.42
State Project No. 301-099

Submitted by:
Stantec Consulting Services Inc.

December, 2010

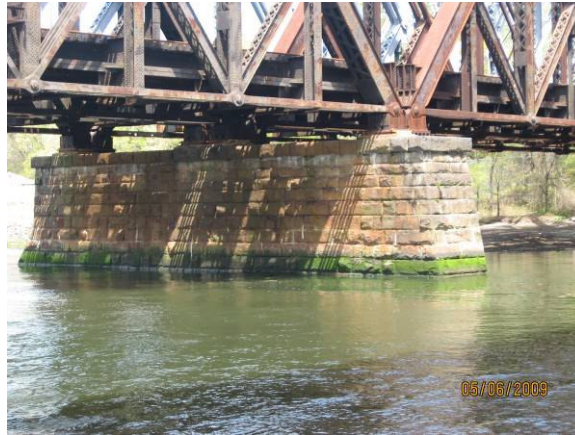
Photo II-4: Typical Masonry Pier

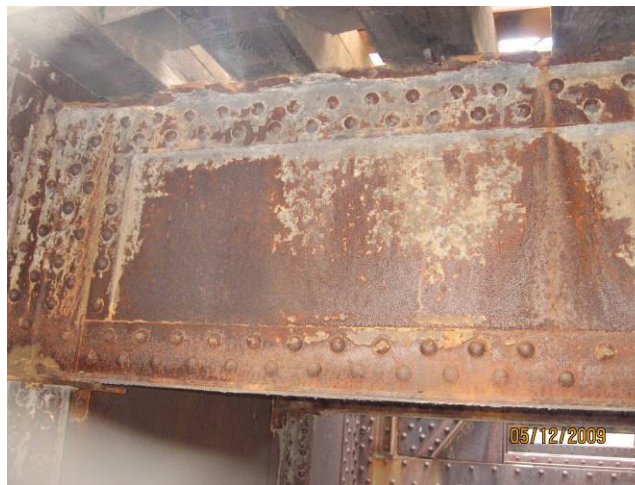
In general, the bridge is in poor condition. The superstructure steel exhibits corrosion, pitting loss of section, general section loss, and impacted rust at various locations throughout. Driving the poor rating of the bridge are conditions of two components of the primary members: the stringers throughout the entire bridge and specifically those under Track 1, and pinned truss connections and associated eye bars of Spans 5, 6, and 7 which are extremely difficult to repair or replace. The stringers typically exhibit loss of section at the top flange in the form of pitting losses at the top plate and/or edge losses of the flange members (up to 100% losses at certain locations). Pitting type web losses were also noted in the stringers.

Photo IV-1: Typical Deterioration of Stringer Top Flange below Track 2

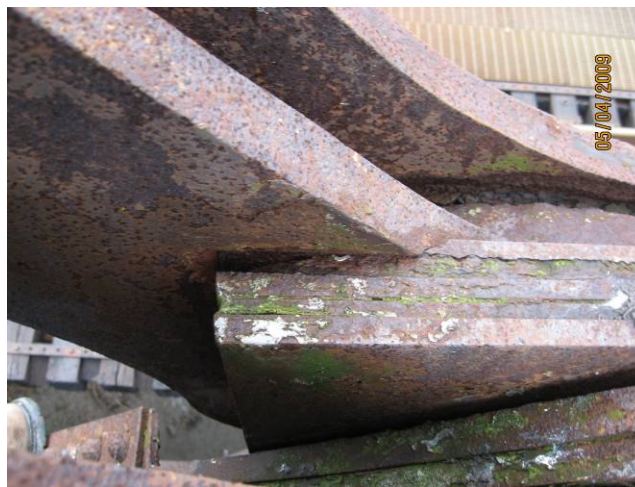
The bridge pins exhibit rotational movement at many locations throughout the bridge. This rotation has resulted in losses in the connecting eye bars due to the members rubbing against each other. The results of the ultrasonic testing examination of the pins did not reveal the presence of any crack-like indicators in any of the truss pins examined.

Photo IV-2: Typical Wear Between Members at Pins (plate cutting into)

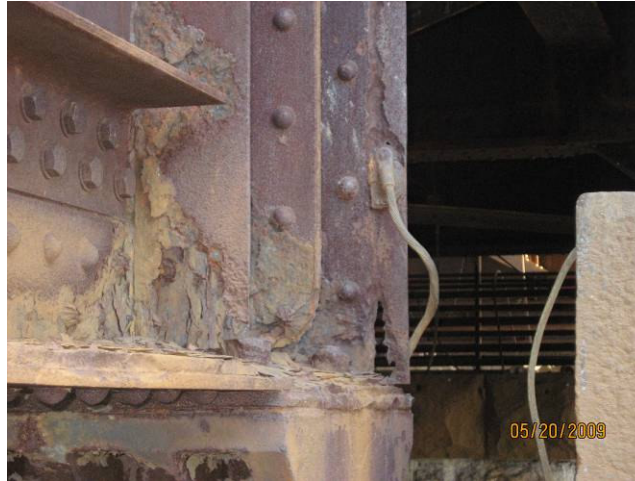
The balance of the structural steel (except for stringers and pinned connections) throughout the remainder of the bridge is generally in fair condition. The primary steel members generally exhibit corrosion, pitting, section loss, and impacted rust at various degree of severity. The connections between stringers and floorbeams generally exhibit moderate to heavy impacted rust and section loss at the bottom of the connection angles.

Photo IV-3: Section loss of bearing stiffener at G8, Span 2

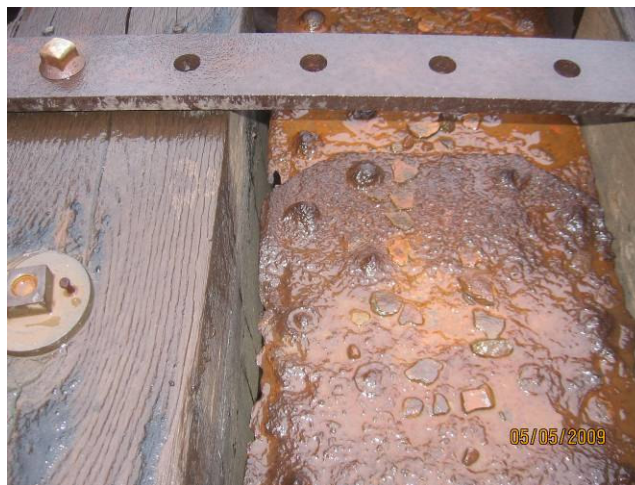
Photo IV-4: Section at top of Floorbeam FB12, Span 1

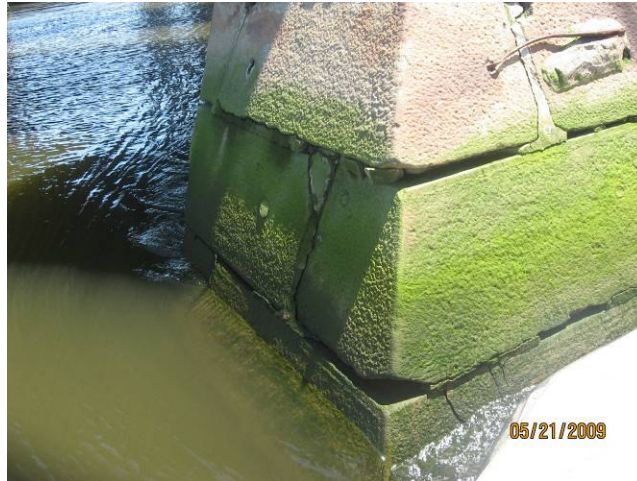
The poor rating of the substructure components is due to exposure and deterioration of pier footings at Piers 2, 3, and 4. Although no undermining was noted, previous underwater inspection reports, along with the current inspection results, indicate active scour (aggregation and degradation) is occurring at all piers. Above the footings, the masonry pier stems as well as the abutment stems are in satisfactory condition, with minor loss of mortar and hairline cracks noted in the masonry.

Photo IV-5: Typical loss of mortar at pier joints

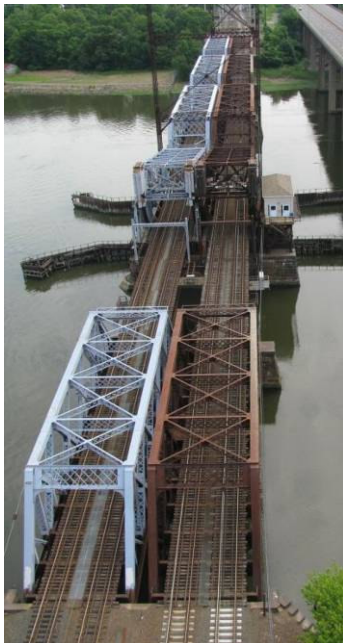
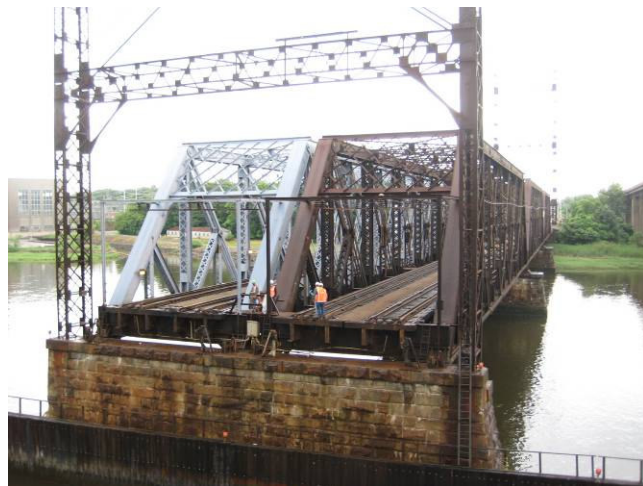
The paint system was found to have completely failed. As noted previously, the bridge is comprised of parallel twin structures. The northerly structure appears to have been repainted from the track level up, while portions below track level are unpainted or have completely failed paint. The southerly structure is completely unpainted. Lead was found in various paint samples taken from the bridge.

Photos IV-6 & IV-7: North (left truss) Truss painted above track level, South (right truss) truss unpainted (both photos looking East)

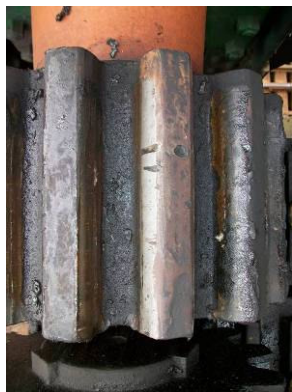
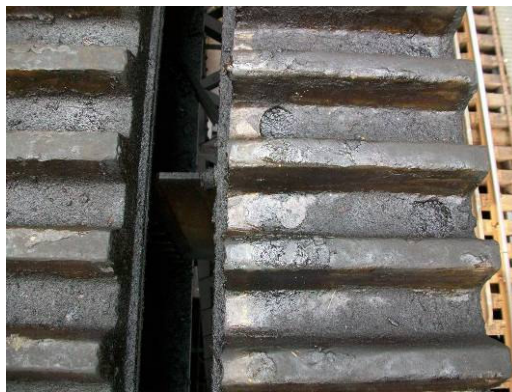
Tooth damage from tooth bottoming was present on the south end of the south rack and pinion of the north leaf $\frac{1}{2}$ ". The tips of the south pinion of the north leaf were ground down presumably to eliminate the bottoming. The extreme south ends were still bottoming. Lubrication of the racks and pinions was old, dried and inadequate. Portions of the teeth were rusting. Tooth alignment was inconsistent at different locations along the racks.

Photos IV-8 & IV-9: Wear and tooth damage to rack and pinion

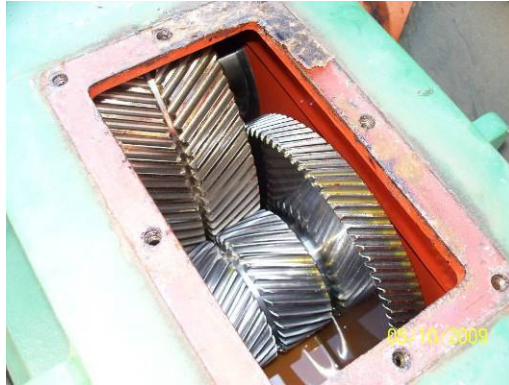
External gear wear ranged from 1% to a maximum of 24%. The enclosed differential speed reducers were in good condition with little indication of wear.

Photo IV-10: Enclosed speed reducer

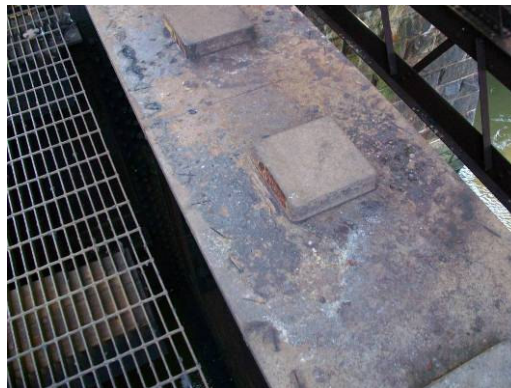
Photo IV-11: Minor pintle wear noted on main tracks

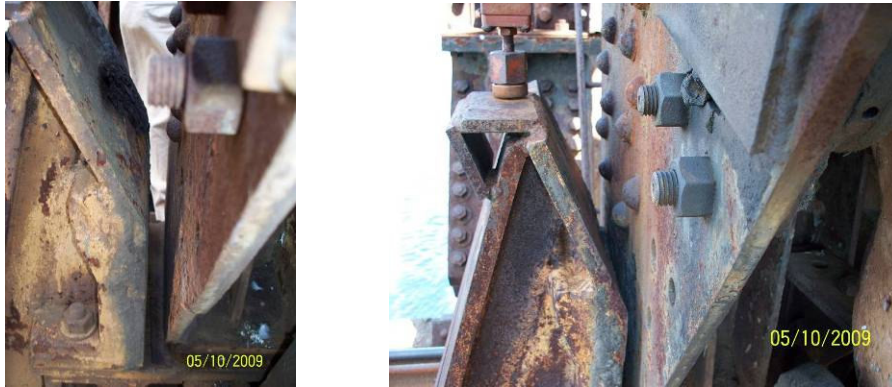
The centering devices consist of vertical bent plates attached to the live load shoes on the extreme north and south sides of each span. There was clearance at the north side of both spans and hard contact at the south side of both spans.

Photos IV-12 & IV-13: Span centering devices – clearance at North side, contact at South side

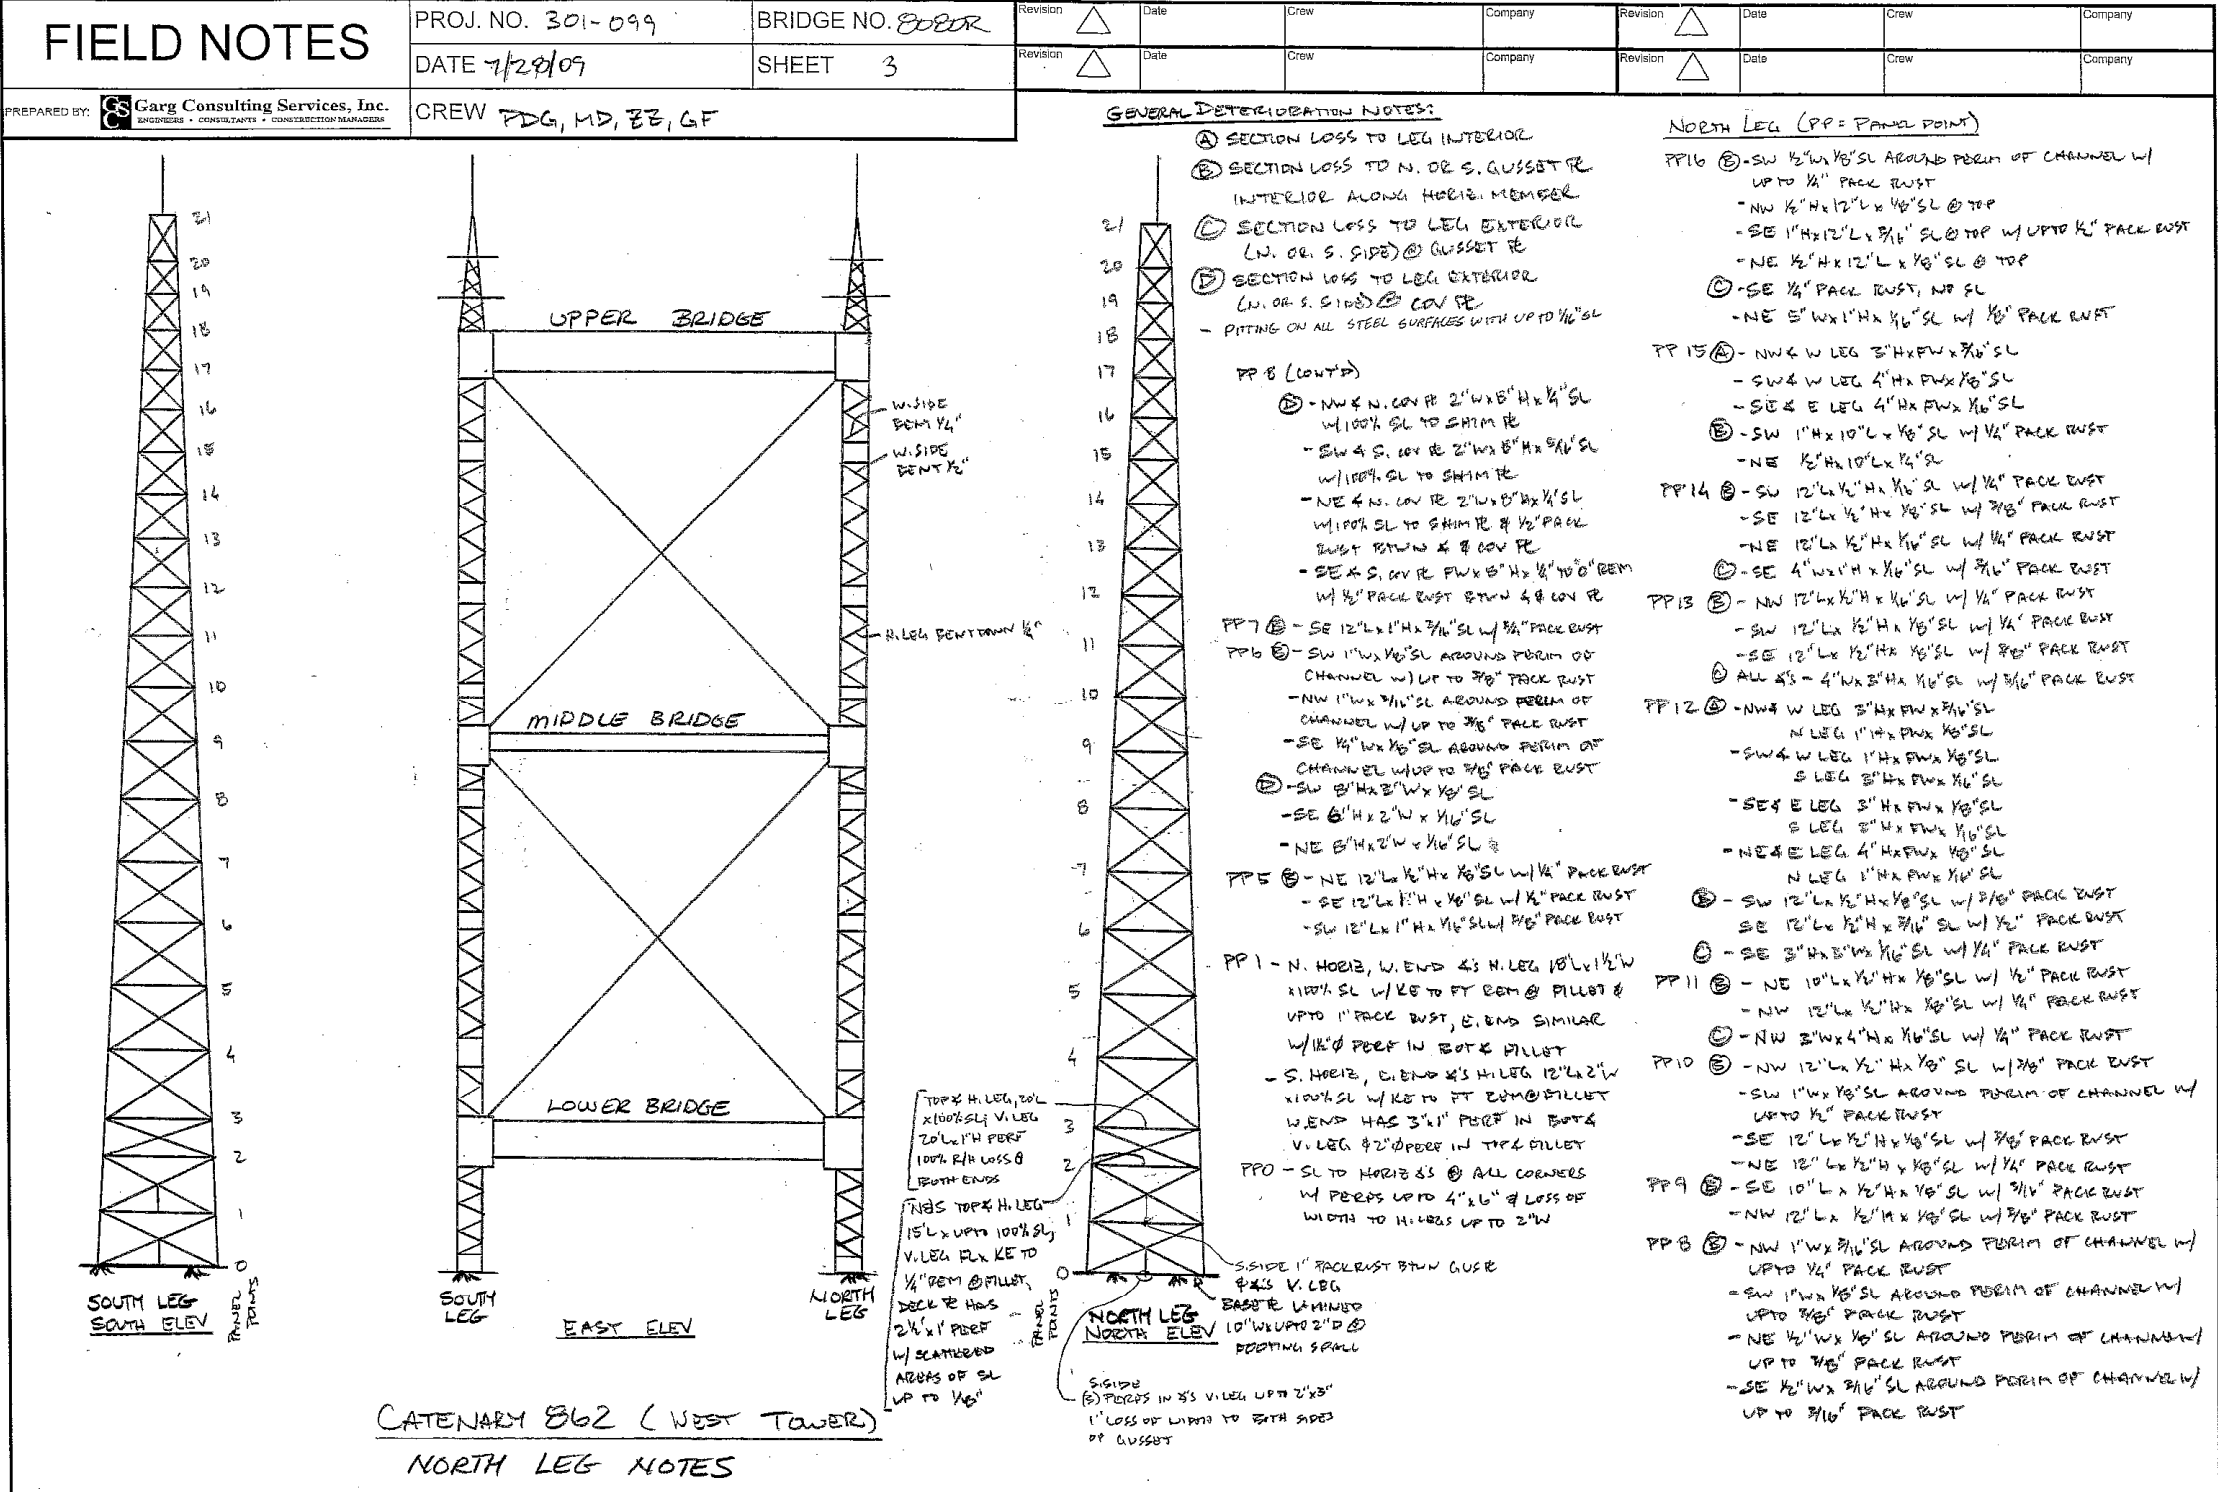
Figure IV-2: High Tower 862 North Leg Inspection Findings

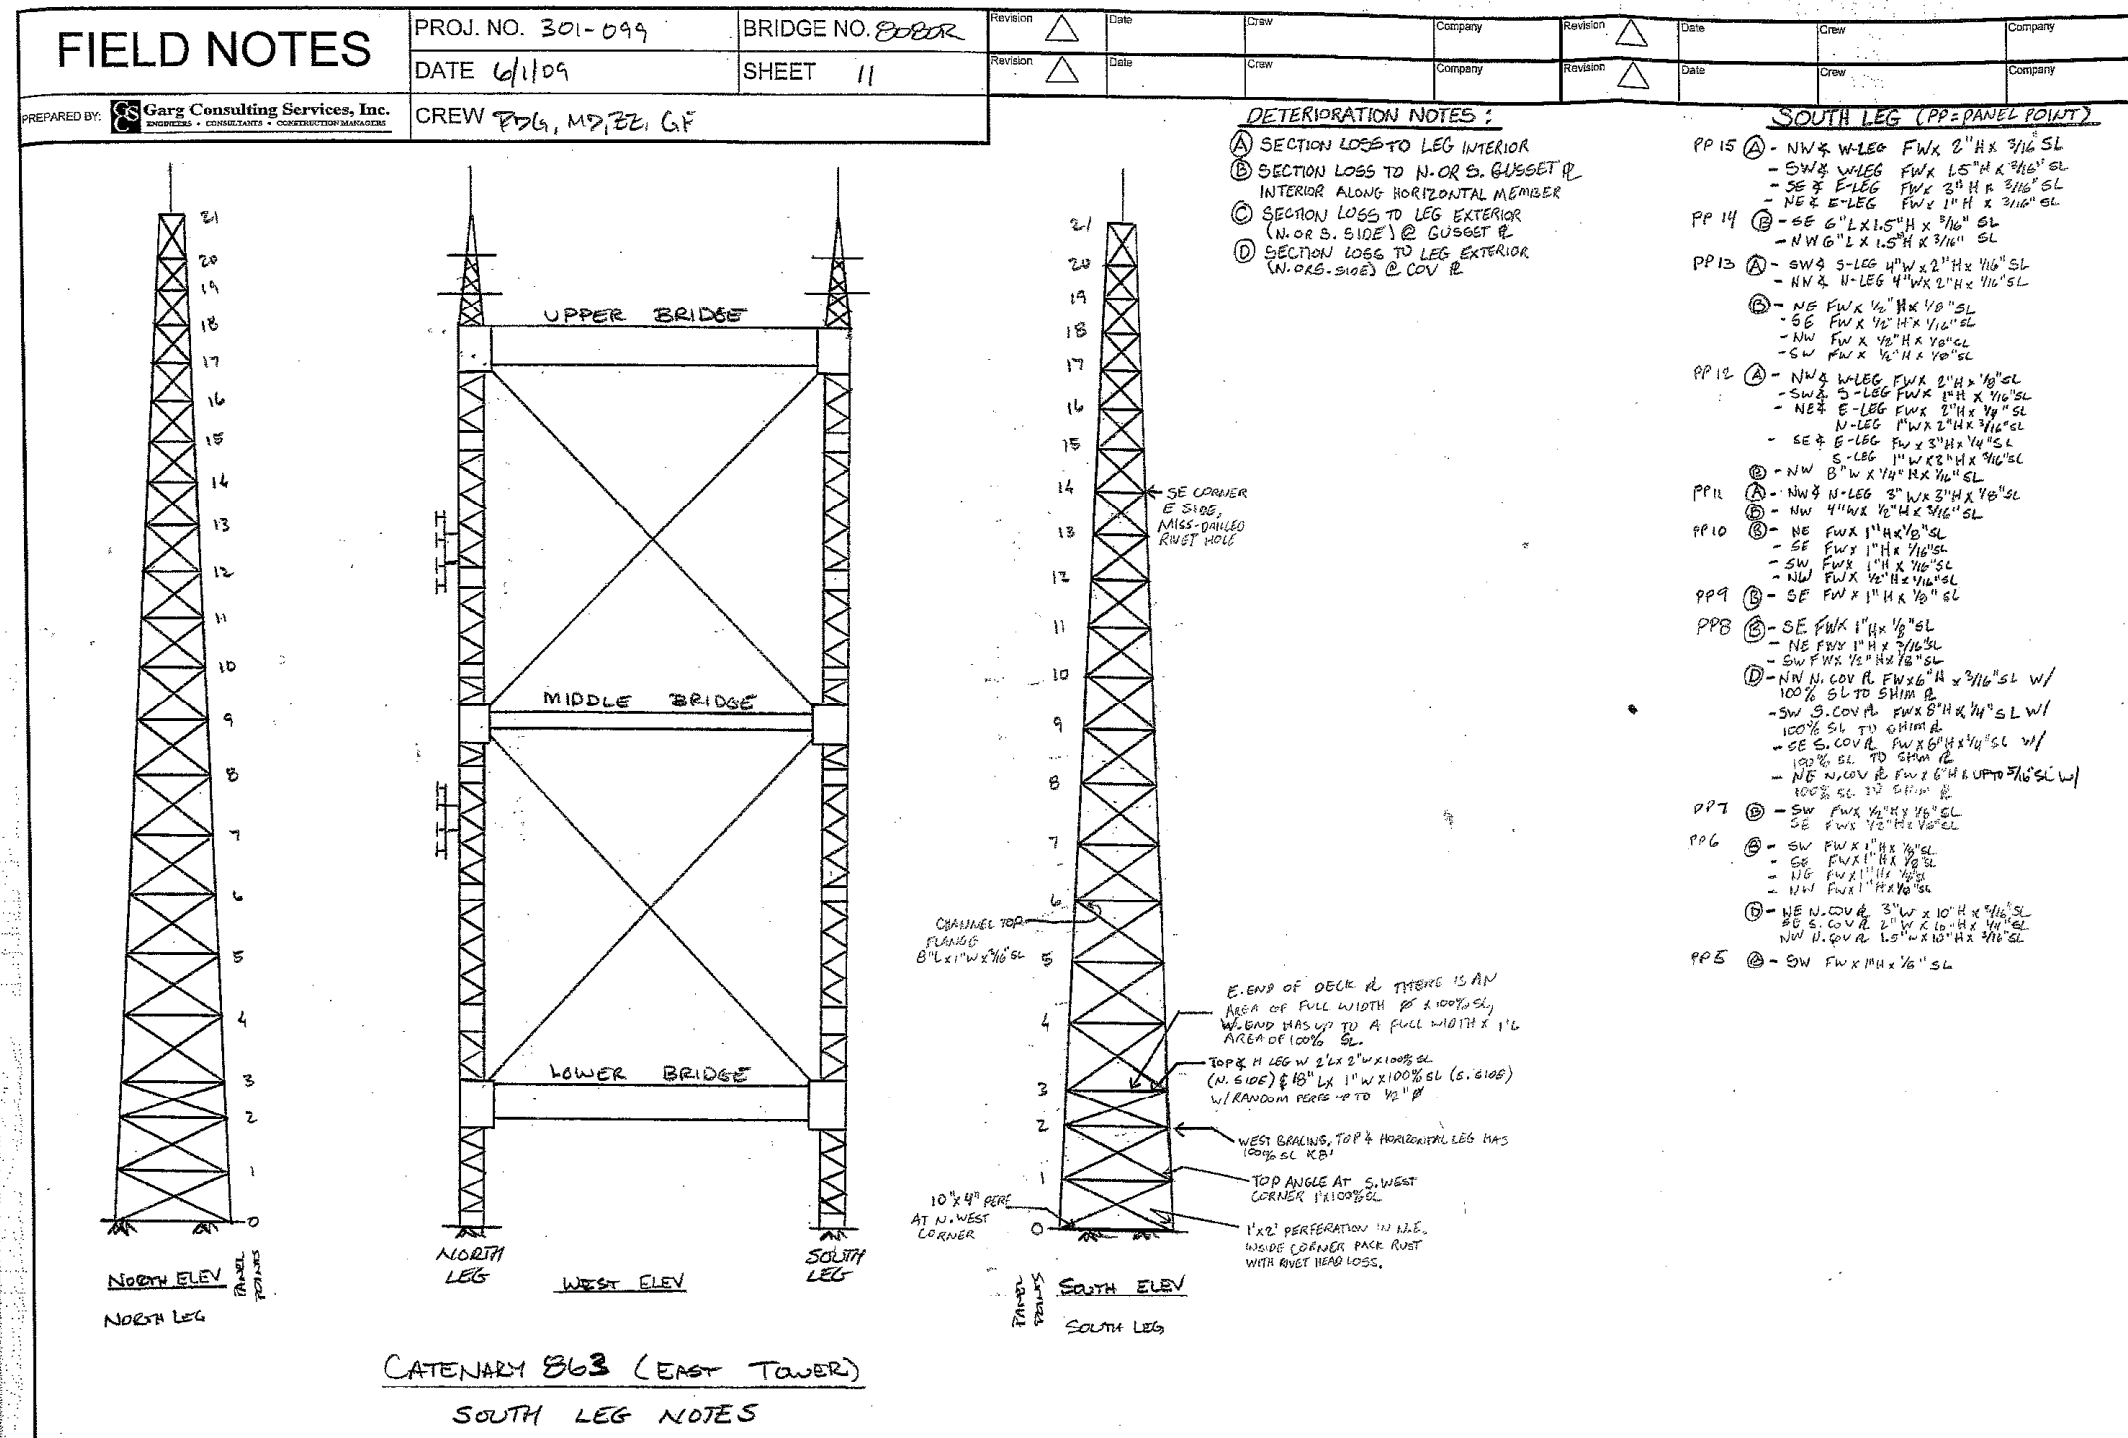
Figure IV-5: High Tower 863 South Leg Inspection Findings
